Geonvironmental impact of October 8 Kashmir Earthquake in Karnah and Uri Tehsils of Jammu and Kashmir

G. M. Bhat, S. K. Pandita, Yudhbir Singh, Sham Singh and Vinay Sharma

Postgraduate Department of Geology, University of Jammu, Jammu- 180 006, J&K, India

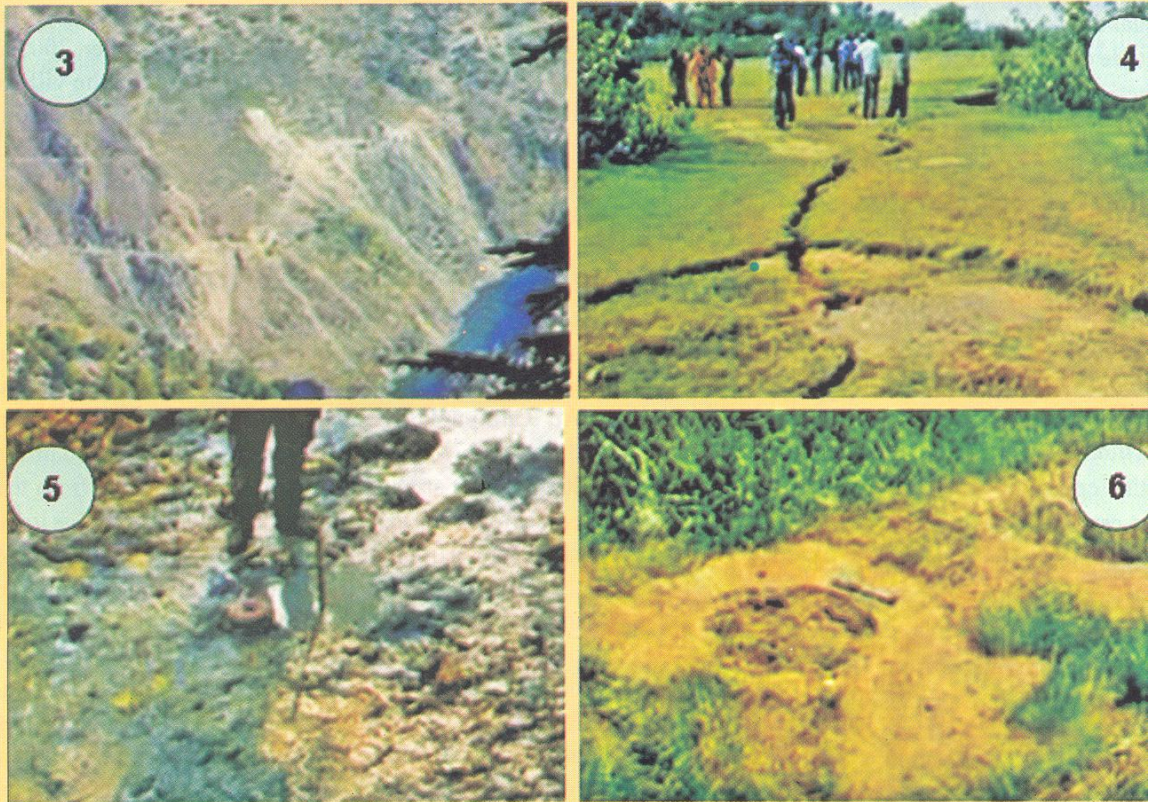
Figs. 3 - 6. Geo-environmental impact of October 8 Kashmir earthquake

Fig. 3. Neelam Valley Road opposite to the Teethwal Township

Fig. 4. Tension cracks in the ground at Simbal Camp, Jammu;

Fig. 5. Sand Blows at Simbal camp, Jammu;

Fig. 6: Liquefaction crater at Kralapura, Kupwara

The Tangdhar-Tithwal valley (Karnah) is drained by two main streams (the Batmaji River and the Qazinag River) which together confluence with the Kishanganga (Neelam) River at Tithwal (Fig. 3).

Simbal camp is situated on the outskirts of Jammu municipal limits at a distance of about 225 km from the epicenter of the October 8 earthquake. Tension cracks are visible on the wet ground and on footpath in the Simbal Camp (Fig. 4). These NE-SW trending cracks range in aperture from 15 to 21 cm. These cracks show a vertical displacement of 2.5 to 5 cm and their depth ranges from 1.5 to 2 m. A few sand blow craters (Fig. 5) are also visible in the area through which brownish sand and water ejected into the air upto 1.5 m at the time of earthquake on October 8. The local youth who were playing in the area at that time narrated their experience of this earthquake. "The ground started trembling and we got frightened and started running away from the ground but could not stand. Suddenly water with sand started gushing out from all over the ground and from the nearby fields. All of a sudden the atmosphere became cloudy. The ground where we sat started cracking and in no time the multiple cracks developed in the field and the footpath".

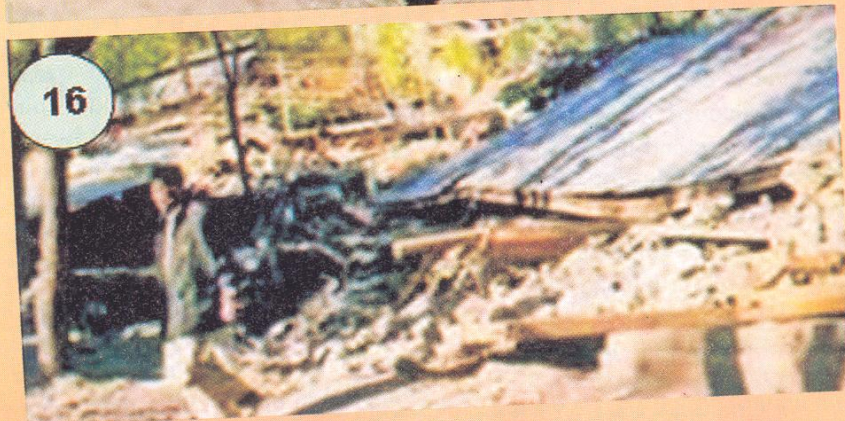
Fig. 16 Destruction to the settlements in Kandi, Karnah.

The damage by the earthquake in Karnah and Uri areas has been severe (Fig. 16) close to the epicenter in the range of 50 km and progressively decreasing away. The intensity of damage at various localities in the surveyed areas on the revised MMI Scale (ABAG, 2003) is given in Table 1. The type of the houses and the percentage of damages are shown in Table 2. In both the areas of Uri and Karnah most of the villages are built either on the older river terraces or on the hill slopes. The constructed houses in these areas are mostly single or double storey un-reinforced earthen wall stone masonry buildings. Stone masonry buildings are more common in these villages. The stone masonry walls consisted of irregularly placed undressed/dressed stones, rectangular and rounded, that were laid in cement sand and mud mortar. A significant number of casualties and injuries were associated with the total collapse of these structures. Un-reinforced one or two storey brick masonry buildings with roofs constructed with wood and CGI tin sheets are also seen in these areas. These structures were also razed to the ground within the 10 km range of LOC. The area affected by major shaking lies within a radius of 50 km from the epicenter with the destructiveness of the shaking reducing quickly as one move away from the epicenter. The intensity of the shaking has been severe in Karnah and Uri Tehsils in the vicinity of LOC. In these areas a very large vertical slip component has caused the extreme damage to the structures. These structures mostly collapsed in place, rather than being thrown over or developing diagonal tension cracks.
